Flood Control Project Maintenance
2009 Structure Summary Report
Overall Unit and Item Ratings

Sacramento County

American River Pumping Plant No. 1 Howe Avenue Storm Drain D - 05

Flood Control Project Maintenance**Unit Cover Sheet****2009 Pumping Plant Inspection Results****Sacramento County**

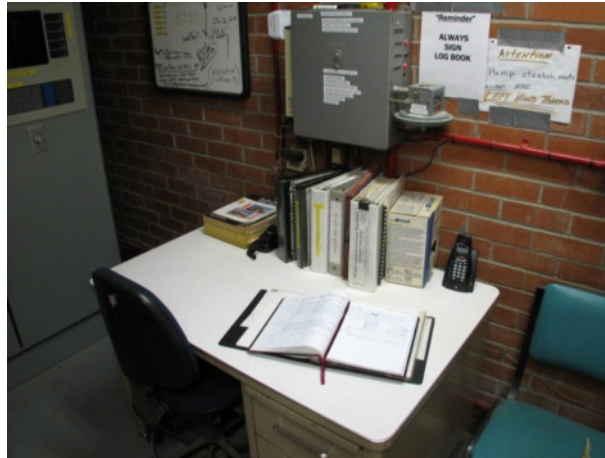
jpaasch_20091228_242.jpg

LMR No.	Levee Mile		Category	Item	Location	Rating	Action/Comment	GPS Latitude/Longitude		Photo	Issue No.
	Start	End						Start	End		
1	0.00	0.00	Pump Stations	Operating Log		A	Inspector Comments: O&M log present at the pump station and is being used and updated	°	°	Y	1
2	0.00	0.00	Pump Stations	Operation & Maintenance Manual		A	Inspector Comments: O&M manual is present at site	°	°		2
3	0.00	0.00	Pump Stations	Plant Building		A	Inspector Comments: Building appears in good structural and operational condition.	°	°	Y	3
4	0.00	0.00	Pump Stations	Communications		A	Inspector Comments: Telephones present. Operators have cellular and radio communication.	°	°		4
5	0.00	0.00	Pump Stations	Safety		A	Inspector Comments: No apparent safety hazards observed that pose a threat to plant operators.	°	°		5
6	0.00	0.00	Pump Stations	Cranes		A	Item inspected visually only. Item was not operated during the inspection. Inspector Comments: Crane and hoist appears to be in good working condition.	°	°	Y	6

Photo of communication station with operation log and maintenance manuals.

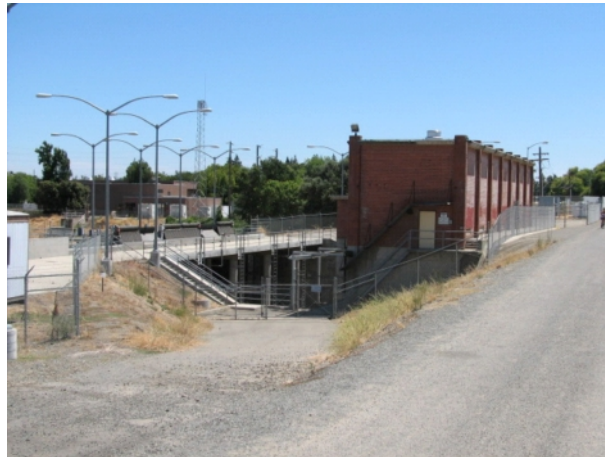
jpaasch_20091228_243.jpg

Photo of pumping plant building.

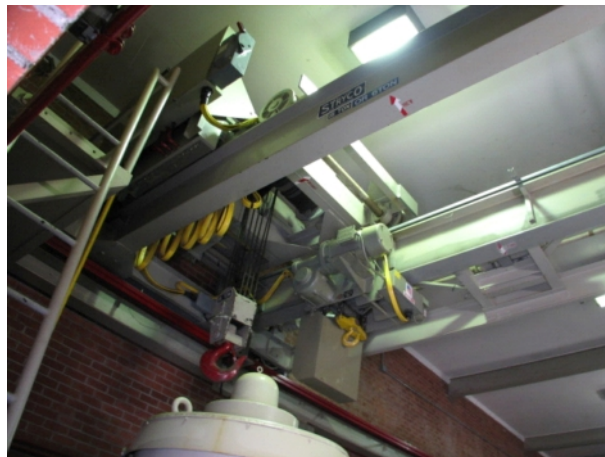
jpaasch_20091228_244.jpg

Photo of overhead crane and hoist.

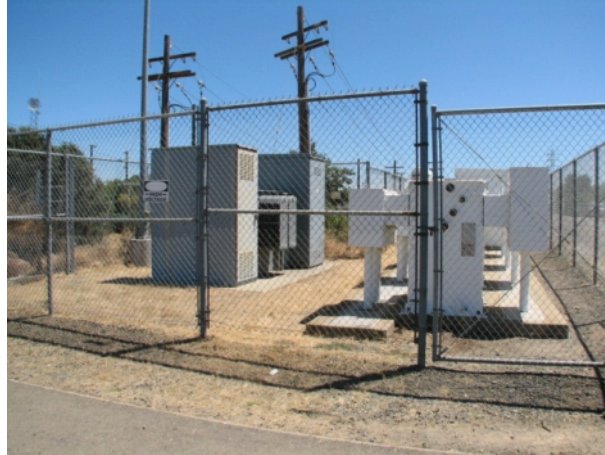
7	0.00	0.00	Pump Stations	Pumps		A	Item inspected visually only. Item was not operated during the inspection. Inspector Comments: Pumps appear properly maintained and lubricated.	°	°		7
8	0.00	0.00	Pump Stations	Power		A	Inspector Comments: No electrical deficiencies were observed. Backup power on site.	°	°	Y	8
9	0.00	0.00	Pump Stations	Motors, Engines, Fans & Gear Reducers		A	Item inspected visually only. Item was not operated during the inspection. Inspector Comments: Motors appear properly maintained and lubricated.	°	°	Y	9
10	0.00	0.00	Pump Stations	Pump Control Systems		A	Item inspected visually only. Item was not operated during the inspection. Inspector Comments: Automatic and manual controls are free of damage and appear to operate properly.	°	°		10
11	0.00	0.00	Pump Stations	Sumps/Wet Well		A	Inspector Comments: Sump appears to be clear of excessive debris and sediment.	°	°		11
12	0.00	0.00	Pump Stations	Trash Racks		A	Inspector Comments: Trash racks are fastened in place and properly maintained.	°	°	Y	12

Levee Mile Report Line	8
Start Levee Mile	0.00
End Levee Mile	0.00
Location	
Category	Pump Stations
Item	Power
Photo of commercial power and backup power,	
jpaasch_20091228_245.jpg

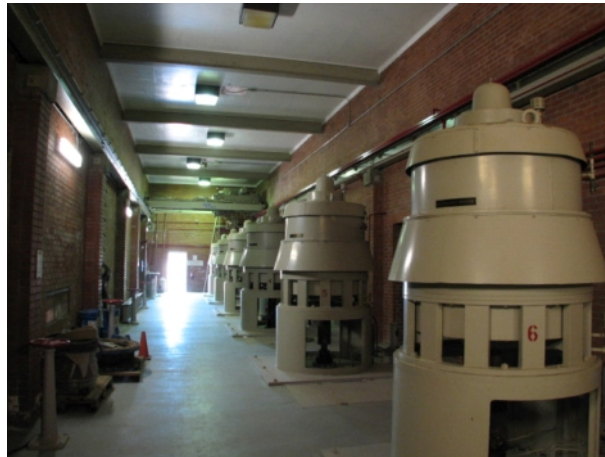
Levee Mile Report Line	9
Start Levee Mile	0.00
End Levee Mile	0.00
Location	
Category	Pump Stations
Item	Motors, Engines, Fans & Gear Reducers
Photo of building interior with all six pump motors in view.	
jpaasch_20091228_246.jpg

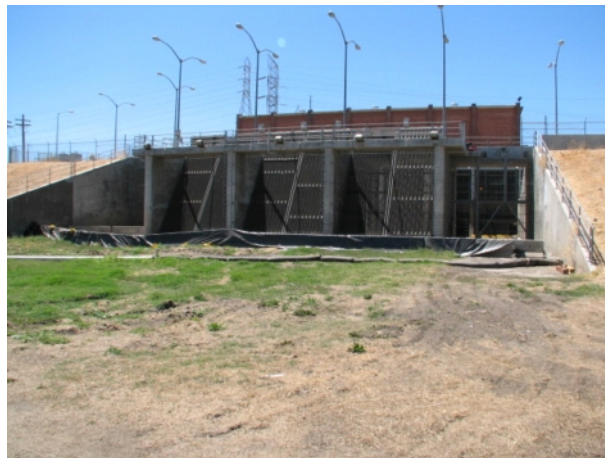
Levee Mile Report Line	12
Start Levee Mile	0.00
End Levee Mile	0.00
Location	
Category	Pump Stations
Item	Trash Racks
Trash racks and rakes are free of debris. Temporary rail in place as part of construction activity for the USACE Common Features project.	
jpaasch_20091228_247.jpg

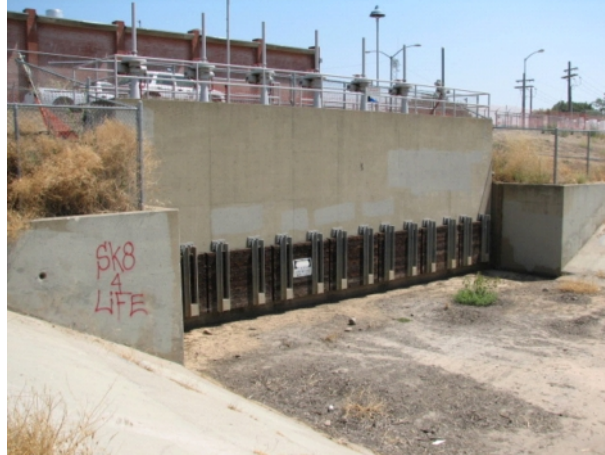
17	0.00	0.00	Pump Stations	Other Metallic Items		A	Inspector Comments: Metal parts are protected from corrosion.	° °	° °		17
18	0.00	0.00	Pump Stations	Flap Gates		A	Inspector Comments: Flap gates open easily and close completely and appear to be in good condition.	° °	° °	Y	18
19	0.00	0.00	Pump Stations	Closure Structures		N	Inspector Comments: Item not present at this site.	° °	° °		19
20	0.00	0.00	Pump Stations	Security Fencing		A	Inspector Comments: Fencing provides adequate protection against unauthorized access.	° °	° °		20
21			Pump Stations	Intake and Discharge Pipes		N	Inspector Comments: Discharge pipes could not be seen.	° °	° °		21
22	0.00	0.00	Pump Stations	Pressurized Pipe		A	Item inspected visually only. Item was not operated during the inspection. Inspector Comments: No evidence of erosion or leakage of pressurized pipe was found.	° °	° °	Y	22

Levee Mile Report Line	18
Start Levee Mile	0.00
End Levee Mile	0.00
Location	
Category	Pump Stations
Item	Flap Gates
Photo of outfall structure, flap gates and gate operators.	
jpaasch_20091228_248.jpg

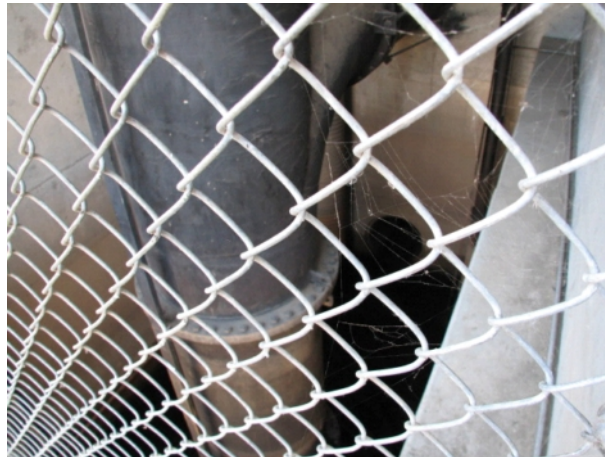
Levee Mile Report Line	22
Start Levee Mile	0.00
End Levee Mile	0.00
Location	
Category	Pump Stations
Item	Pressurized Pipe
Photo looking down into the wet well. Pipe appears to be in good condition.	
jpaasch_20091228_249.jpg

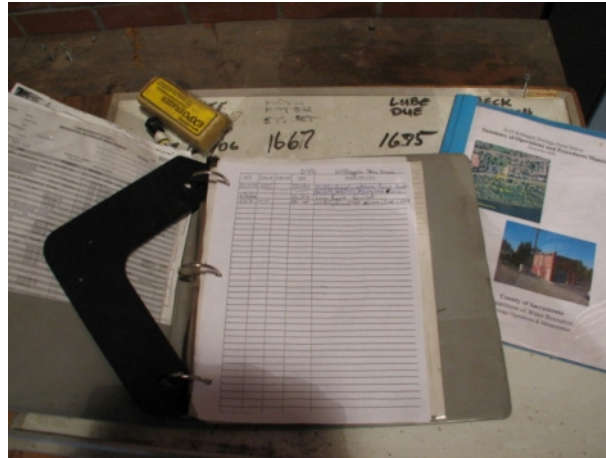
jpaasch_20090810_18.jpg

Photo of operation and maintenance logs.

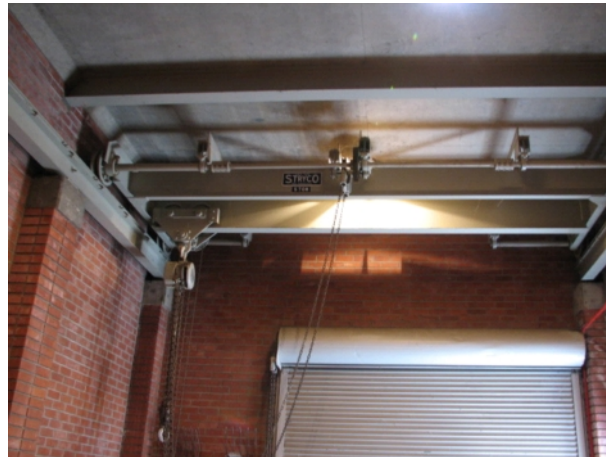
jpaasch_20090810_19.jpg

6	0.00	0.00	Pump Stations	Cranes		A	Item inspected visually only. Item was not operated during the inspection. Inspector Comments: Crane and hoist appears to be in good working condition.	°	°	Y	6
7	0.00	0.00	Pump Stations	Pumps		A	Item inspected visually only. Item was not operated during the inspection. Inspector Comments: Pumps appear properly maintained and lubricated.	°	°		7
8	0.00	0.00	Pump Stations	Power		A	Inspector Comments: No electrical deficiencies were observed. Placement and use of backup power present at site.	°	°	Y	8
9	0.00	0.00	Pump Stations	Motors, Engines, Fans & Gear Reducers		A	Item inspected visually only. Item was not operated during the inspection. Inspector Comments: Motors appear to be properly maintained and operational.	°	°	Y	9
10	0.00	0.00	Pump Stations	Pump Control Systems		A	Item inspected visually only. Item was not operated during the inspection. Inspector Comments: Automatic and manual controls are free of damage and appear to operate properly.	°	°		10

Photo of crane and hoist.

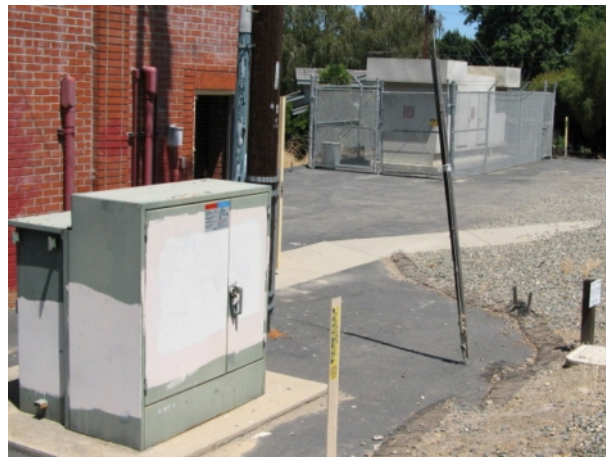
jpaasch_20090810_24.jpg

Photo of commercial power transformer and generator backup.

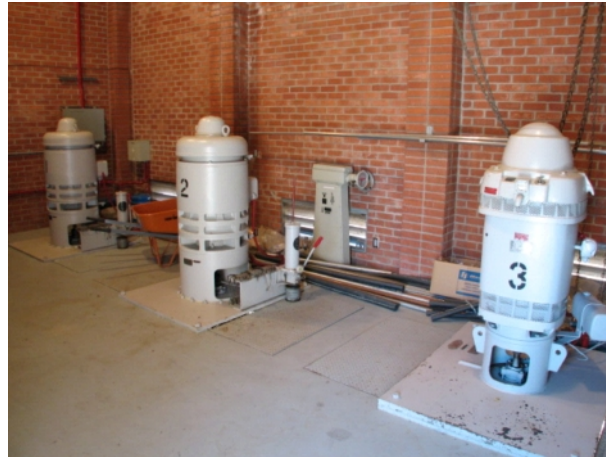
jpaasch_20090810_20.jpg

Photo of three pump motors.

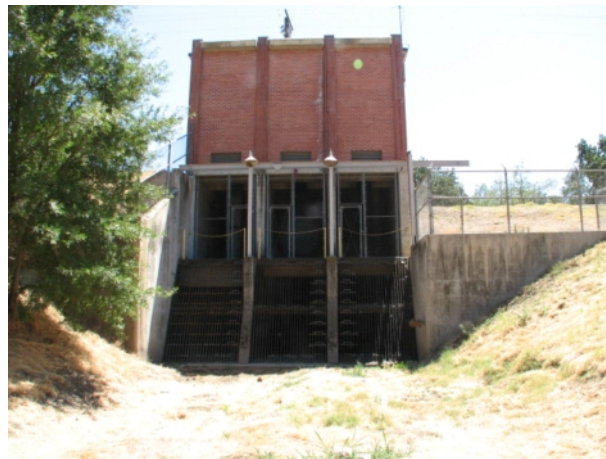
jpaasch_20090810_21.jpg

11	0.00	0.00	Pump Stations	Sumps/Wet Well		A	Inspector Comments: Sump appears to be clear of excessive debris and sediment.	°	°		11
12	0.00	0.00	Pump Stations	Trash Racks		A	Inspector Comments: Trash racks are fastened in place and properly maintained.	°	°	Y	12

Photo of trash racks and exterior of building.

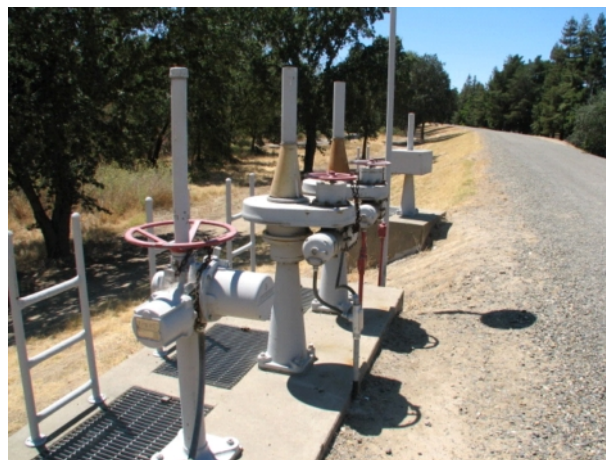
jpaasch_20090810_22.jpg

Photo of electric and manual gate operators at the outfall.

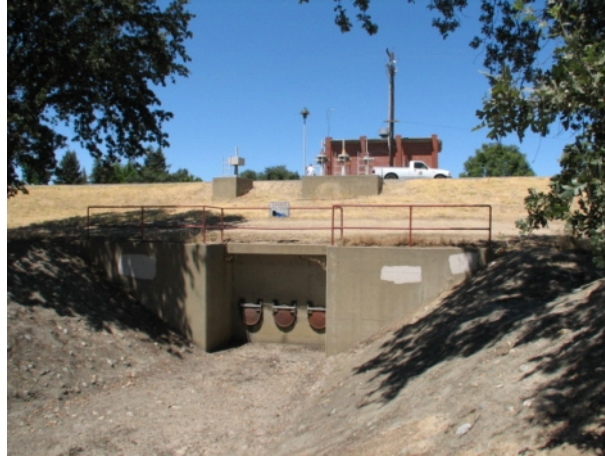
jpaasch_20090810_23.jpg

18	0.00	0.00	Pump Stations	Flap Gates		A	Inspector Comments: Flap gates open freely and close completely and appear to be in good condition.	°	°	Y	18	
19	0.00	0.00	Pump Stations	Closure Structures		N	Inspector Comments: Item not present at this site.	°	°		19	
20	0.00	0.00	Pump Stations	Security Fencing		A	Inspector Comments: Fencing provides adequate protection against unauthorized access.	°	°		20	
21	0.00	0.00	Pump Stations	Intake and Discharge Pipes		N	Inspector Comments: Pipes are not visible for inspection.	°	°		21	
22	0.00	0.00	Pump Stations	Pressurized Pipe		A	Item inspected visually only. Item was not operated during the inspection. Inspector Comments: Visible segments of pressuized pipe in the wet well appear free of corrosion and leaks.	°	°		22

Photo of flap gates and the outfall structure.
